# Procedures for the Evaluation of Sheet Membrane Waterproofing

SPECIAL REPORT

# Special Report 99-11

Prepared for  
NEW ENGLAND TRANSPORTATION CONSORTIUM

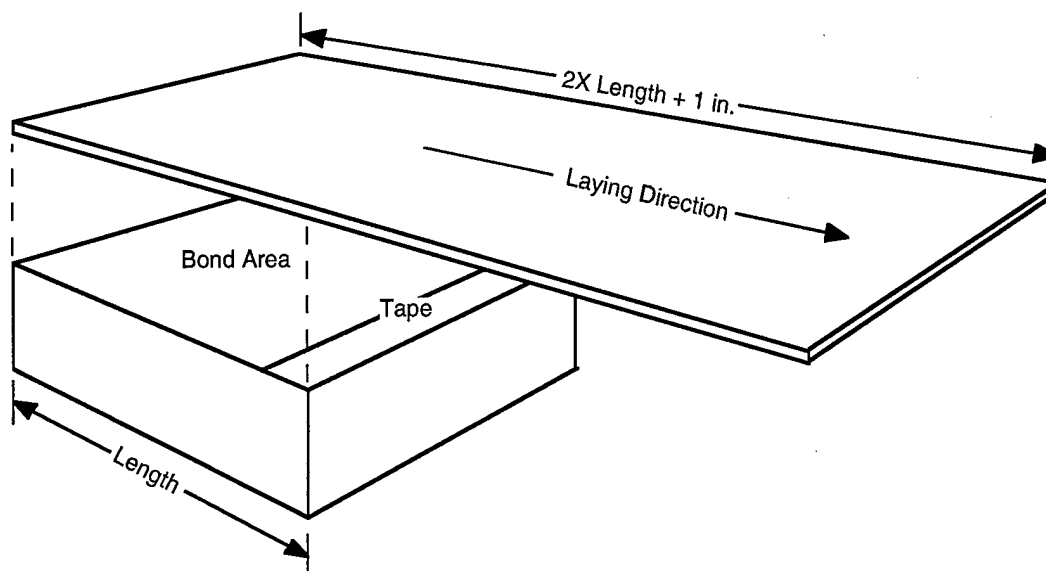
Figure 1. Fabrication of test specimens.

- At room temperature, mix one weight of Type I portland cement with two weights of Ottawa sand (20–30 grade) according to ASTM C305.
- Cast mortar into 6- × 6- × 21-in. (15- × 15- × 53-cm) molds and cover with sheet of plastic.
- After 24 hours, strip molds and cure mortar beams in room-temperature limewater for 14 days.

- Cut beams into 6- × 6.38-in. (15.2- × 16.2-cm) slices.
- Sand slices (slabs) with 24-grit silicon-carbide sandpaper until surface is flat and all saw marks are removed.
- Oven dry the mortar slabs at 220°F (104°C) for 24 hours.
- Clean sanded surface with dry, stiff fiber bristle brush.
- Place 0.75-in. wide strip of tape across one end of slab.
- Apply primer to the test surface.
- Allow primer to cure to a tack-free finish.
- Apply membrane according to manufacturers' instructions.
- Condition specimens at approximately 70°F (21°C) and 50% RH (relative humidity) for a minimum of 14 days.
- Cut membrane into five 1-in.- (2.5-cm) wide strips through to the mortar with a sharp razor knife.
- Start cuts 0.50-in. (1.3 cm) from edge of slab.

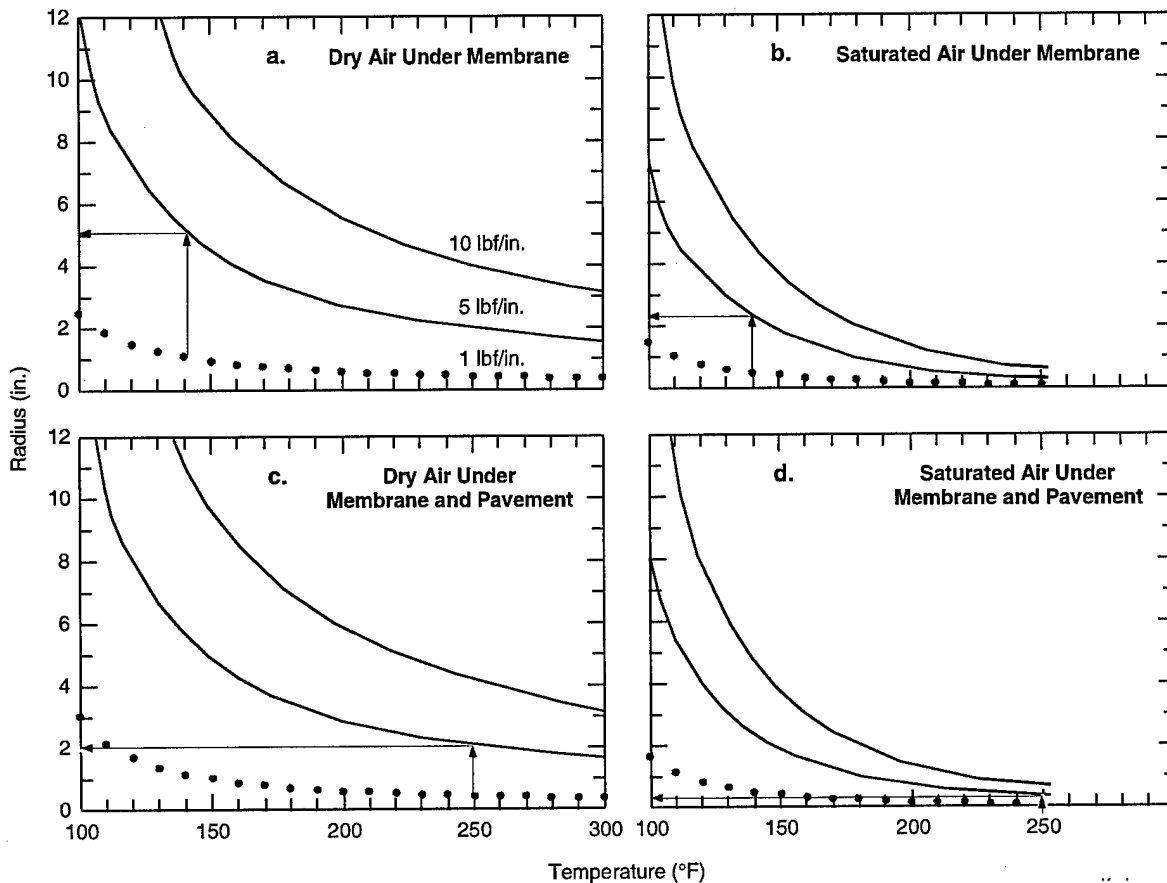
Figure 3. Relationship between minimum void size, peel strength, and internal void temperature. Blister pressure, which relates to temperature, was determined by considering dry and moist air to be ideal gases. The temperature of 70°F (21°C) represents atmospheric pressure.

Figure 3, developed from eq 2, illustrates this concept. It consists of four graphs, each composed of three curves, where each curve represents peel strength plotted against temperature and critical size. Each graph defines the smallest void expected

to blister. For example, if an air pocket beneath a membrane adhered to a deck at 5 lbf/in. (875 N/m) is heated from 70° to 140°F (24° to 67°C), a 5.2-in. (13.2-cm) radius would be the smallest void that could blister (Fig. 3a). However, if the air beneath the membrane is continually water saturated, the critical void would reduce to 2.25 in. (5.7-cm) radius (Fig. 3b). Of course, higher bond strengths are more resistant to blistering, but one must realize that heat, the driving force of blisters, softens the adhesive and diminishes peel strength. Thus, the 5-lbf/in. force used in the above analogy is considered conservative, even though some membranes adhere more tightly to concrete at room temperature.

its overburden increases more than 20-fold (a membrane weighs between 0.002 to 0.008 lb/in.<sup>2</sup> whereas 2-in.-thick asphalt pavement weighs approximately 0.168 lb/in.<sup>2</sup>). In this situation we see that the critical size changes from a 2.1-in. (5.3-cm) radius when the void space is dry (Fig. 3c) to a 0.30-in. radius when it is wet (Fig. 3d). Moreover, blisters do not just expand once, they continually increase in size. Korhonen (1986) found this to be true for roof blisters as did Hironaka and Holland (1986) for pavement blisters. Thus, once a blister initiates, no matter how small it may be, it eventually grows large enough to become a big problem.

Though Figure 3 represents idealized situations (a blister is not rigid and self-contained), clearly a nonporous membrane exposed to the sun will remain blisterless if its voids are smaller than 5.5 in. (14 cm) across (Fig. 3b). When exposed to the intense heat of freshly laid pavement, approximately quarter-sized voids (0.9 in., or 2.4 cm) (Fig. 3d) can lead to problems. Other scenarios are possible for blisters but the quarter coin size should be useful as a rule of thumb for bridge inspectors to distinguish when a membrane is being inadequately adhered to a deck. A permeable membrane can reduce blistering by allowing pressure build up to escape through the membrane. However, the section on water vapor permeance reveals that the membranes in this study were not very breathable.
